MISSION™ PRODUCTS

Fluid End Expendables

Application and Troubleshooting Guide

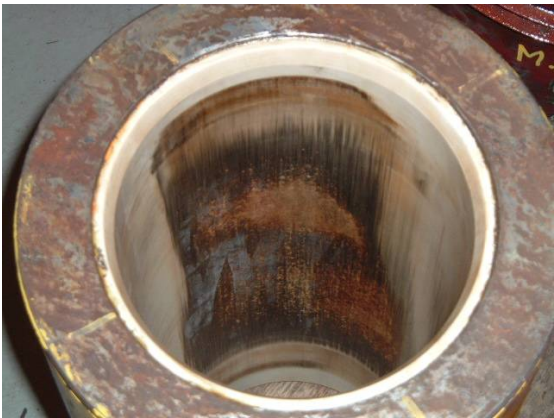
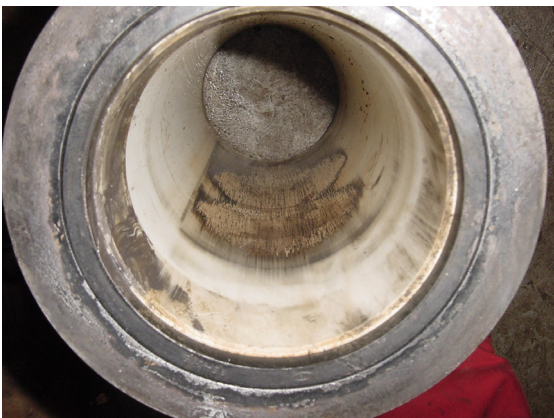
Photographs of scoring in liner bore disrupting ceramic surface.

The main mode of premature failure of the ceramic liner is caused by the disruption of the ceramic surface in the piston stroke area. This is normally caused by the piston's metal body coming in hard sliding contact with the ceramic surface. This hard sliding contact may be the result of a misaligned pump or a piston left in operation too long after failure begins. The amount of damage done to the surface in a given amount of time would depend on the degree of misalignment or, in the

The disruption of the surface is caused by the microscopic fracture of the ceramic material. These fractures are similar to glass fractures and are very abrasive on the mating component (in this case, the piston). The fractured material is also very hard and will remain in place unless the liner is repaired by re-honing the bore, thereby renewing the liner. A liner that has a damaged bore can usually be identified by a discoloration of a section of the bore and the texture of the bore will not be as smooth as the opposing side.

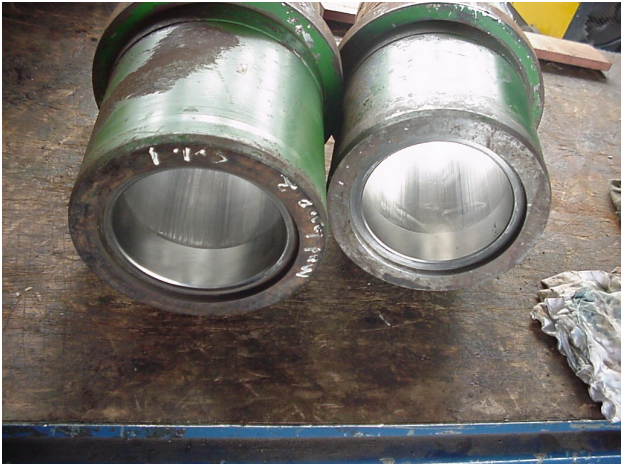
Liner operated with short rod.

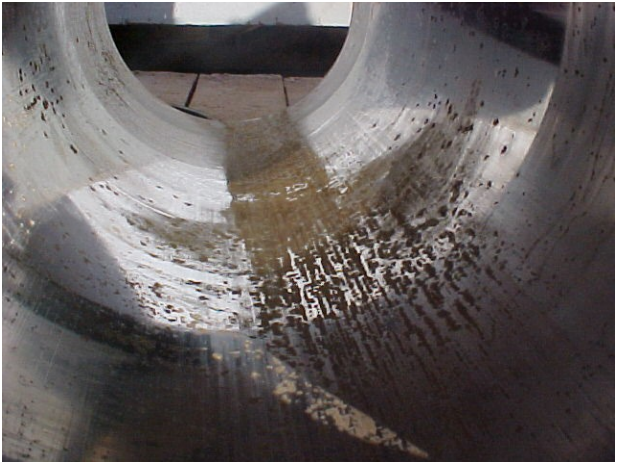
Liner operated in acidic or caustic fluid.

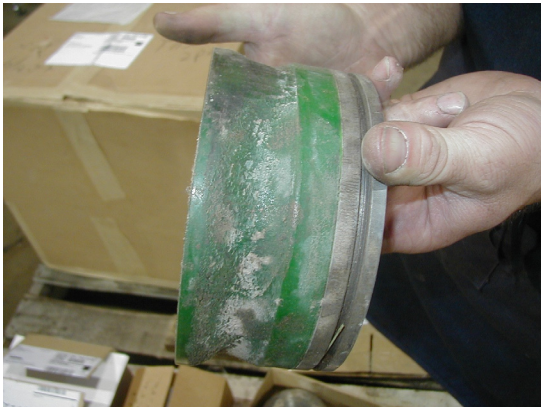
Green Duo Heat Damage

HEAT: Urethane pistons that fail due to heat have a loss of material and acquire a surface similar to a melted candle. This condition can be a result of high fluid temperature, inadequate backflush supply or frictional heat due to other forces. As the temperature increases, the mechanical properties of the urethane decrease. Standard (not high temperature compounds) urethane pistons have a maximum temperature of approximately 180° F (82° C). This maximum temperature is the sum of the temperature of the fluid being pumped plus the frictional heat generated by the reciprocating piston.

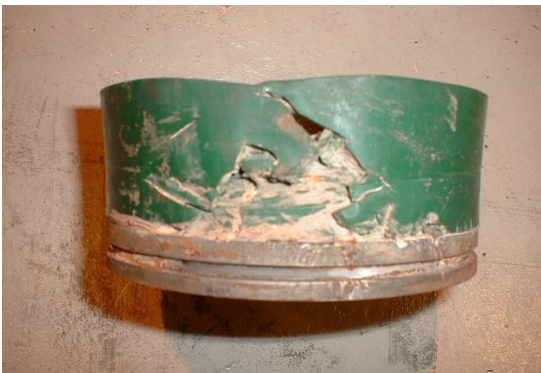
Green Duo Extrusion Damage

EXTRUSION: Urethane pistons that fail due to extrusion look torn and are very rough in appearance. They also have a loss of material emanating from the piston flange upward. Edges of the urethane surface will be sharp and rough to the touch. Premature piston failure due to extrusion usually indicates that the liner bore to piston flange gap was too great for the pressure operated.

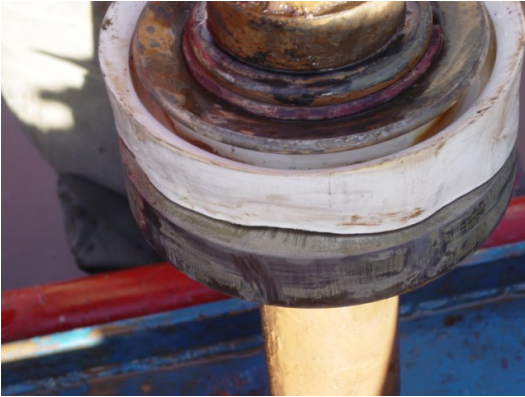
White Lightning Heat Damage

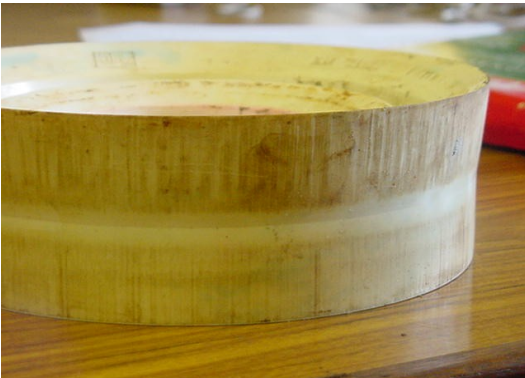
White Lightning in High Solids

ABRASION: Urethane pistons that fail due to abrasion have loss of material and the surface will be rough but not torn. Longitudinal streaks will normally be observed on these pistons where solids have been entrapped between the urethane compound and the liner and operated for some time.

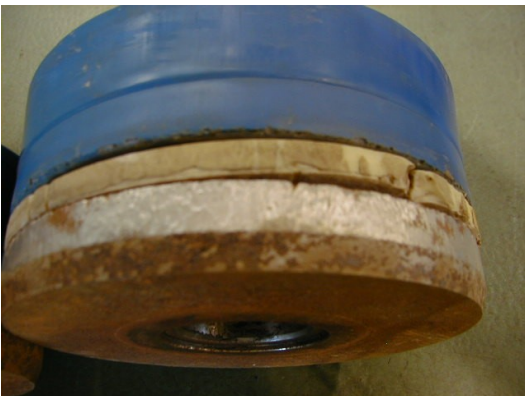
Blue Lightning Heat Damage

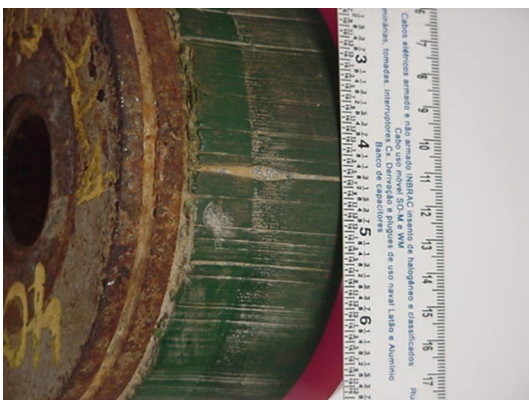
Green Duo in High Solids

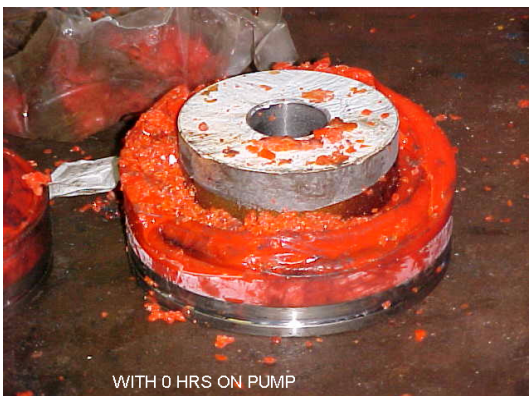
Competitor's Piston Age Hardened

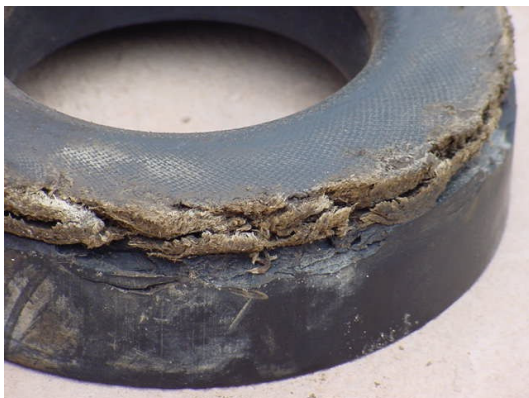
Rubber Operated on Worn Body

EXTRUSION: Under extrusion conditions and also while putting rubbers on worn out piston bodies, if the liner is too worn or the rubber is installed on a too worn piston body, the piston rubber fabric will extrude into the gap between the body and liner and be severed. With every stroke more material will extrude into this gap and be severed, leaving a void at the piston rubber / piston body interface. This will continue until the fabric no longer supports the rubber face and the piston lip fails. Visual characteristics include fabric loss, loss of lip material and a rough surface in the rubber lip. In pressures above 2,500 psi, it is not recommended that the customer change piston rubbers on used piston bodies. Beyond this pressure it is not economical to do so because of the reduction in piston rubber life, increased downtime and increased liner wear.

The Supreme piston bodies have grooves machined into the piston flange to gage wear. The deep groove is for operating pressures of 0 to 1,500 psi, the shallow groove is for pressures between 1,500 psi and 2,500 psi. If operation is between one of these two pressure ranges, the appropriate wear groove can be used to gage if the piston body can be redressed with another piston rubber kit to renew the piston. If the wear on any part of the piston flange is deeper than the associated wear groove for the operating pressure, the piston body is considered worn out and should not be redressed with another rubber kit.

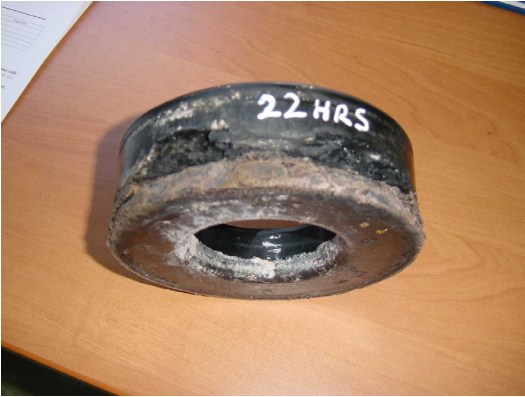
Rubber Extrusion Damage

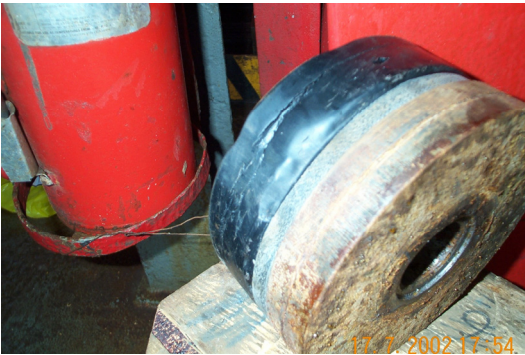
Heat Damaged Piston

HEAT: Once the rubber has exceeded a certain temperature, the rubber will take on a smell of burnt rubber. This smell will not go away. Sometimes the outer surface will become charred and hard to the touch. Carbon black may rub off the piston if it has seen very high temperatures. The high temperatures can be a result of the same mechanisms as the urethane piston. As the operating temperature increases, the mechanical

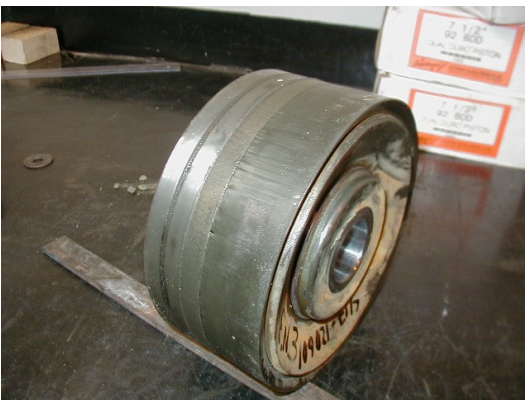
Wear from Abrasion

ABRASION: Under abrasive conditions, the black rubber piston will show a loss of material and the loss should be uniform in appearance. The rubber may also have longitudinal streaks in the rubber and fabric where solids have been entrapped and reciprocating under pressure in the liner.

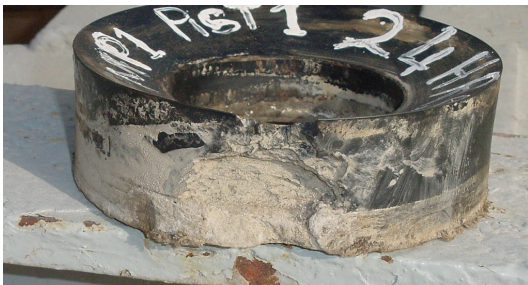
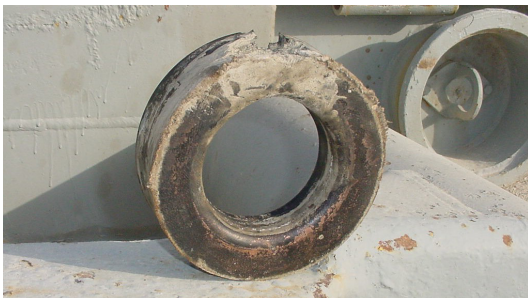
Photographs of a Piston Rubber Operated on a Worn Out Piston Body

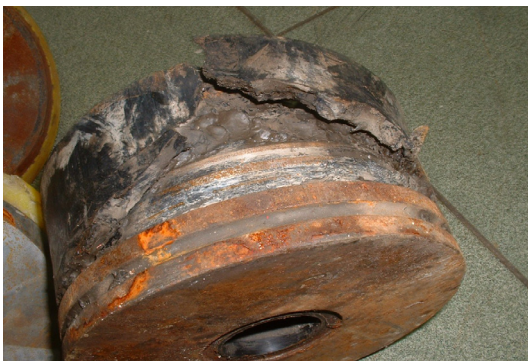
Flex Lip in a Worn Out Liner

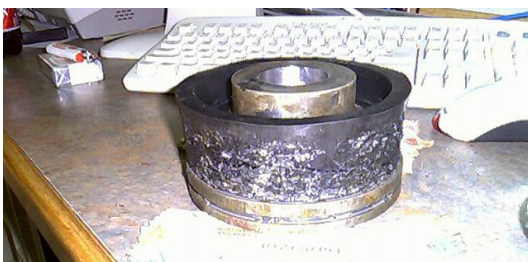
Flex Lip Heat Damage

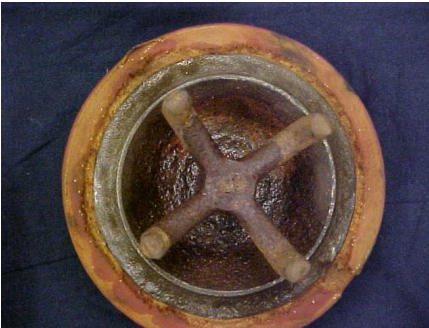
Roughneck Extrusion Damage

EXTRUSION: Extrusion is the most common type of valve failure. If the metal part of the striking bevel of the valve does not contact the seat, a gap will be present. In operation, the insert material will flow into this gap. The amount of material that flows into the gap will depend on the gap size, the operating pressure and temperature. For a given gap size, the higher the operating pressure, the more of the insert material will flow into the gap. Once the material is into the gap, a portion of it can be pinched or severed off. This action, over time, results in a missing section of the insert at the insert/valve body interface. This results in a torn appearance. This tearing action of the insert can continue until a large enough section is lost to cause ultimate valve failure. The gap

can be caused by solids in the system, misaligned or worn upper valve guide or installing a new valve into a worn seat. A gap can also be caused by re-orienting the existing valve in the same seat (rotating the valve).

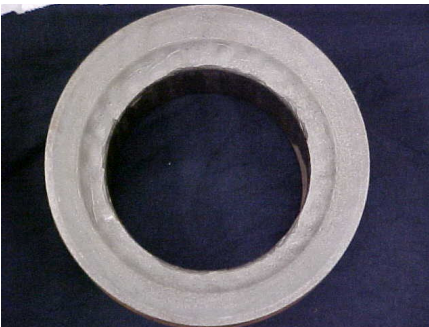
Two Valves Used in Seat

Installing a new valve in a used seat is never recommended. Installing a used valve from another seat is also not recommended. When installing a new valve and seat, a new spring should always be installed. The spring loses its spring rate (stiffness) over a specified time and number of actuations. A 50-lb/in spring can be reduced to a 5-lb/in spring over time. A lightweight spring can cause valve hammering and can damage both the valve and seat metal components thereby reducing life substantially.

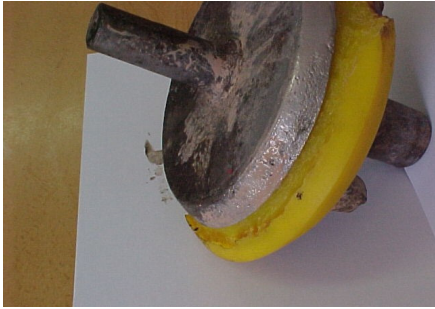
Supreme Extrusion Damage

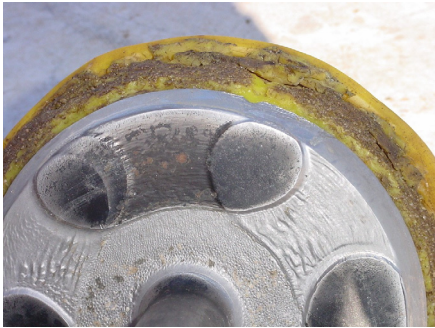
Valve Manually Rotated

As a valve and its associated seat wear, they become a mated component. The valve and seat wear together to maintain a seal and prevent insert extrusion. If a valve is rotated or removed for inspection and re-installed, the valve and seat are no longer mated and must operate a length of time before they are mated again. During this time period the insert may extrude and the metal components may wear at an accelerated rate. If, when a valve and seat are installed, the end user uses a paintstick to put a mark through the valve and seat for orientation purposes, the valve can be inspected and re-installed in the same location. This will reduce insert extrusion and metal wear while still permitting periodic inspection. If the pressures are low enough to permit insert changes, the valve should still be re-installed back into its original seat and orientation to achieve maximum life.

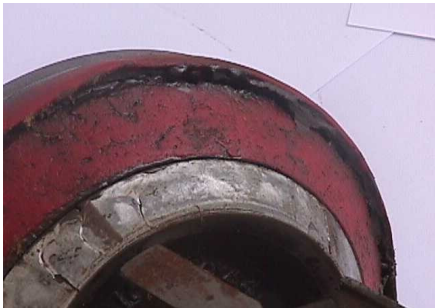
Large Solids and Abrasion

ABRASION: Simple abrasion is different than abrasion from corrosion. Simple abrasion is directly attributed to the fluid medium being pumped and its abrasive qualities. Sand, quartz, iron filings, etc. are all very abrasive materials. Even though the valve body and seat are heat treated to increase the hardness and the insert is highly resistant to abrasion, these components will abrade down. Fluid mediums with abrasive matter are continuously supplied to and through the valve and seat. This matter gets crushed into sharp pieces by the metal part of the valve and tries to embed itself into the insert material causing small tears. Over time the surface of the insert will wear down faster than the valve body and a loss of insert seal will take place. The valve will fail at this point.

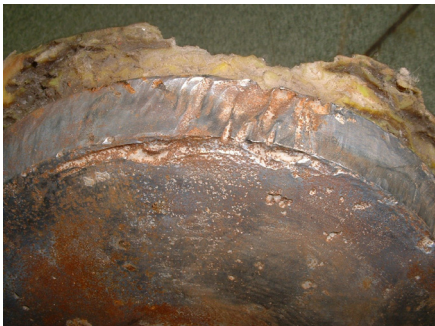
Solids and Corrosion

CORROSION: On a microscopic level, clean metal rusts instantly. As a valve actuates under pressure in certain fluid mediums, the insert wipes the adjacent seat area to clean metal. On a microscopic level, rust develops in this area immediately. After the next valve actuation, the insert wipes this rust off and the area is clean metal again. Over many actuations, small microscopic pits begin to form due to this rusting/wiping action. After time, these microscopic pits start to merge together and after still more time they grow to the visual stage. At this stage, this corrosion pitting with very sharp edges begins to abrade the insert. As the pitting continues and the pits grow larger, the more abrasive they are to the insert. Over time, the insert will be abraded to the point that there is no interference between the insert and the seat. At that point, the valve will fail. The time frame before failure depends on how corrosive the fluid medium is, how fast the pump strokes and the operating pressure.

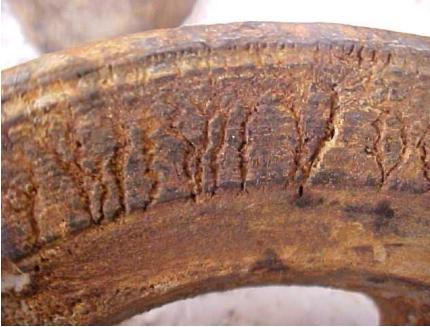
Supreme Seat Corrosion

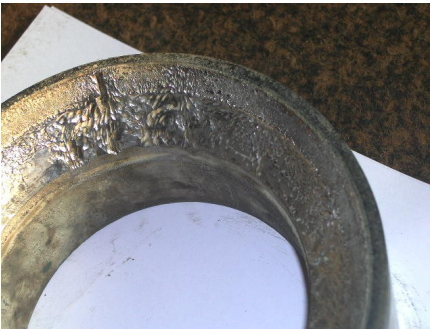
Roughneck Seat Corrosion

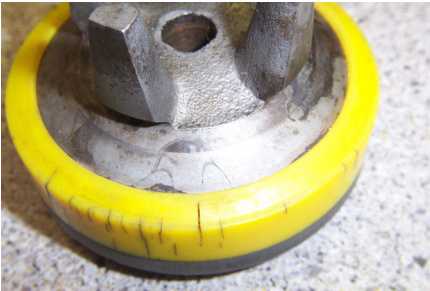
Age Hardened Insert

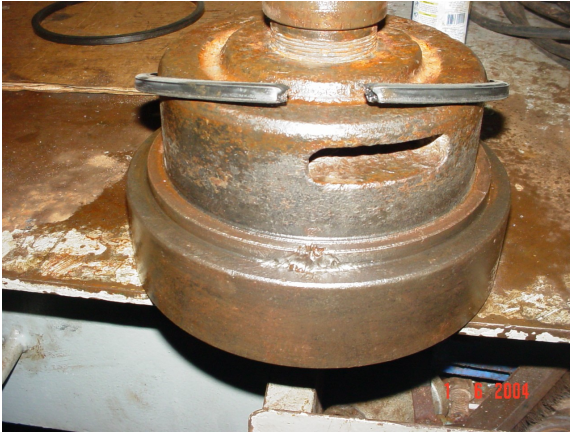
Gasket Installed on Worn Valve Cap and Not Greased Prior to Operation

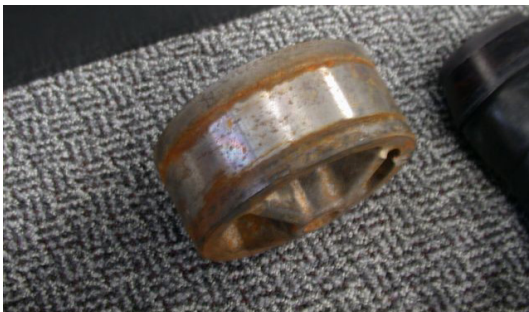
Good Taper Contact National Pump

The valve seat taper and pump deck taper are manufactured to very precise dimensions and tolerances. These include the actual taper, roundness of taper, flatness of taper and the taper dimensions. These precise manufacturing processes and dimensional control allow the metal-to-metal seal that is required under pressure. Because of the precision nature of these surfaces, sanding, lapping, grinding or emery cloth polishing of these surfaces is not recommended. These actions can result in the creation of a low spot on the

taper which can reduce the area of support and the metal-to-metal sealing ability of the assembly. Any contaminants found on the valve seat or pump deck taper should be removed in a nonabrasive circular manner, careful not to disturb the original metal surface. High spots from dents on top of the pump deck should be repaired. If these high spots from dents extend down into the tapered surface, they should be repaired carefully removing only the elevated section of the taper using a circular motion and not an up and down motion.

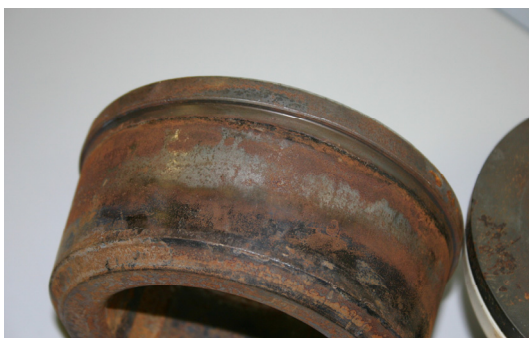
Poor Taper Contact API Taper Pump

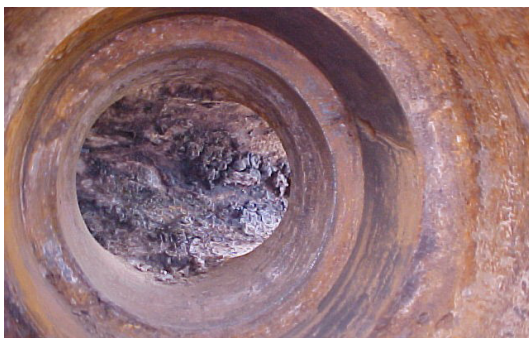
Washed Out Module (Module Worn Out)

As a pump valve pot deck wears, the actual metal-to-metal seal area between the valve pot and seat is reduced. This contact area on a new valve pot and new seat should be a continuous band and, at a minimum, 80% the full height of the seat contact. As the valve pot wears, this contact band will still be continuous around the seat but the thickness of the band will gradually be reduced. At the point before failure, the continuous contact band could be $\frac{1}{2}$ " or less. Once the band fails to be continuous, a washout between the seat and valve pot will occur. Once a seat is removed from the pot, this contact band can be visually inspected and preventative measures can be taken to eliminate or greatly reduce the possibility of valve pot washout.
